Manhole Inspection Summary

Manhole # S41E__037MH

Insp Date: **5/22/08 9:09 AM**

Location Address: **1260 n central ave**

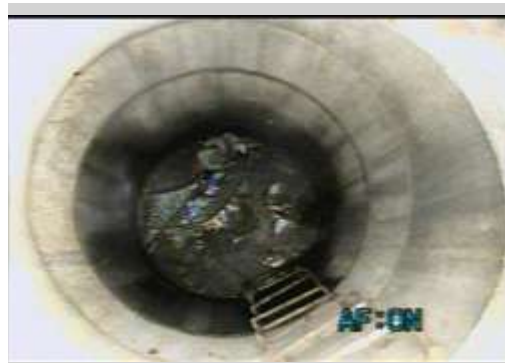
Top View

Steps Count: **10** Missing: **0** ☒ **Corroded**

top view & steps

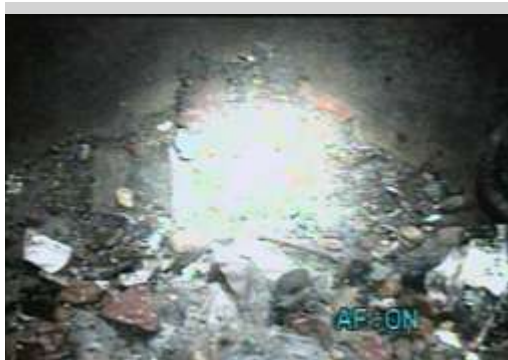
Defect 3

Condition: ☐ Sound ☐ Cracked ☐ Root Intrusion ☐ Deteriorated ☐ Leaks ☒ **Debris**

bench debris

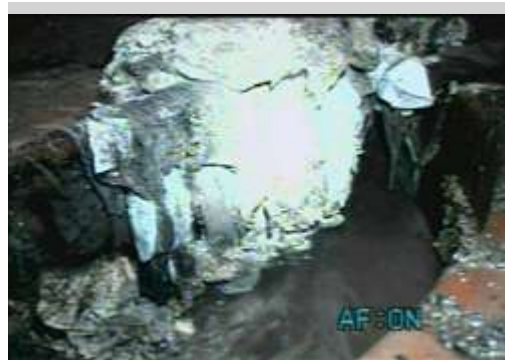
Defect 2

Condition: ☐ Sound ☐ Cracked ☐ Root Intrusion ☐ Deteriorated ☐ Leaks ☒ **Debris**

channel debris

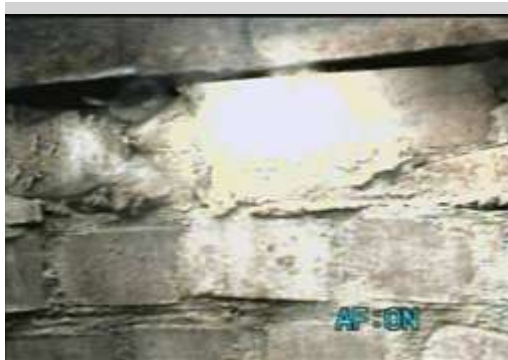
Defect 1

Condition: ☐ Sound ☐ Cracked ☐ Root Intrusion ☒ **Loose Brick** ☐ Deteriorated

chimney loose bricks frame adj

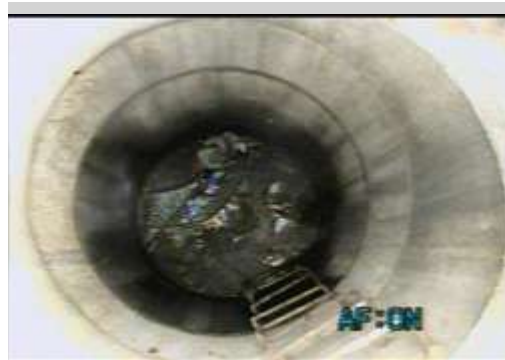
Defect 4

corroded steps

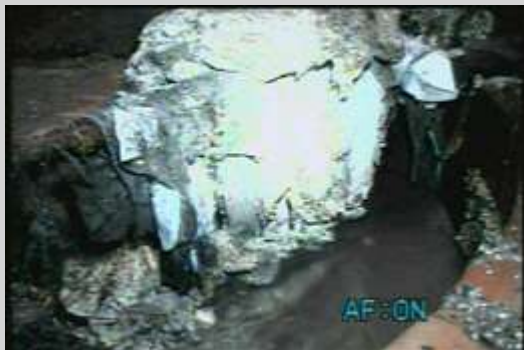
12 O'Clock Outflow

8 in. Circular Gravity Sewer
Pipe Out @ 12 O'Clock

Pipe Height: **0** (in.) Direct
Pipe Material: **PVC** ☐ Pipe Lined
Invert Depth: **13.44** (ft.) Flow Characteristics: **Fast**
Deposits: ☐ None ☐ Mud ☐ Sludge ☒ **Debris** ☐ Grease
Silt Depth: **8** (in.) Deposits Extent: **Heavy**
Infiltration: **None** Pipe Seal Cond: **Unknown**

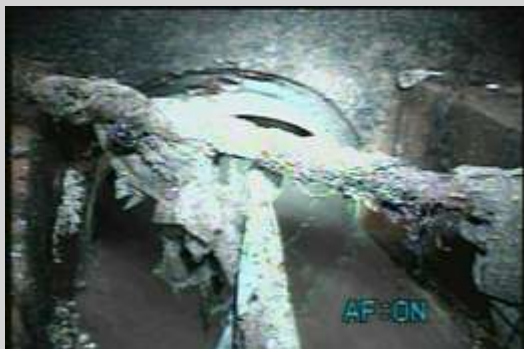
9 O'Clock Inflow

8 in. Circular Gravity Sewer
Pipe In @ 9 O'Clock

Pipe Height: **0** (in.) Direct
Pipe Material: **PVC** ☐ Pipe Lined
Invert Depth: **13.36** (ft.) Flow Characteristics: **Fast**
Deposits: ☐ None ☐ Mud ☐ Sludge ☒ **Debris** ☐ Grease
Silt Depth: **5** (in.) Deposits Extent: **Heavy**
Infiltration: **None** Pipe Seal Cond: **Unknown**
